Coal Burner Condition and Estimated Remaining Life Evaluation of Intermountain Power Project Units 1 & 2

Final Report

Coal Burner Condition and Estimated Remaining Life Evaluation - Intermountain Generating Station

August 15, 1990

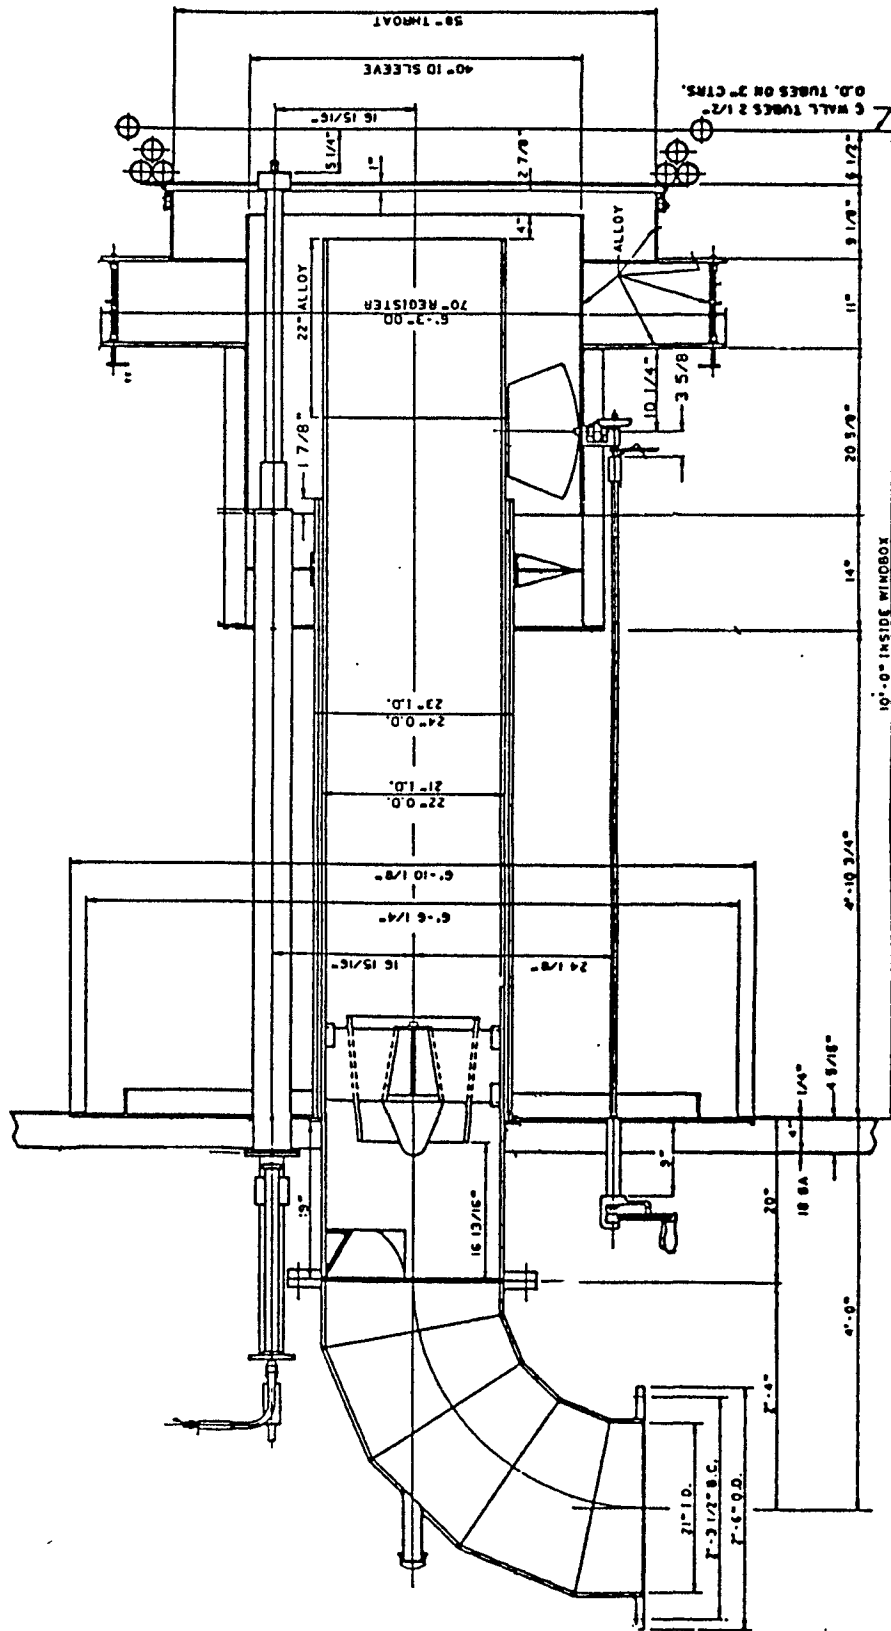
Figure 2

Approximately one year after commercial service began, each unit received new B&W Heavy Duty (H.D.) Air Registers on each upper level of burners due to complications with the original registers. The original 70" dual register burner is illustrated in Figure 2. The burner is considered "high input" by B&W because

the design heat input and physical size were greater than all previous dual register burner applications. The H.D. type register replacement corrects some of the problems experienced with the original burner. The door shaft diameter has been increased from 1/2" to 3/4". The door shafts are fixed in place and the door rotates on the shaft. The linkage has been moved from behind the rear plate to the center of the register, and is not affected by the expansion of the rear plate. These changes have simplified the burner and have improved its operation.

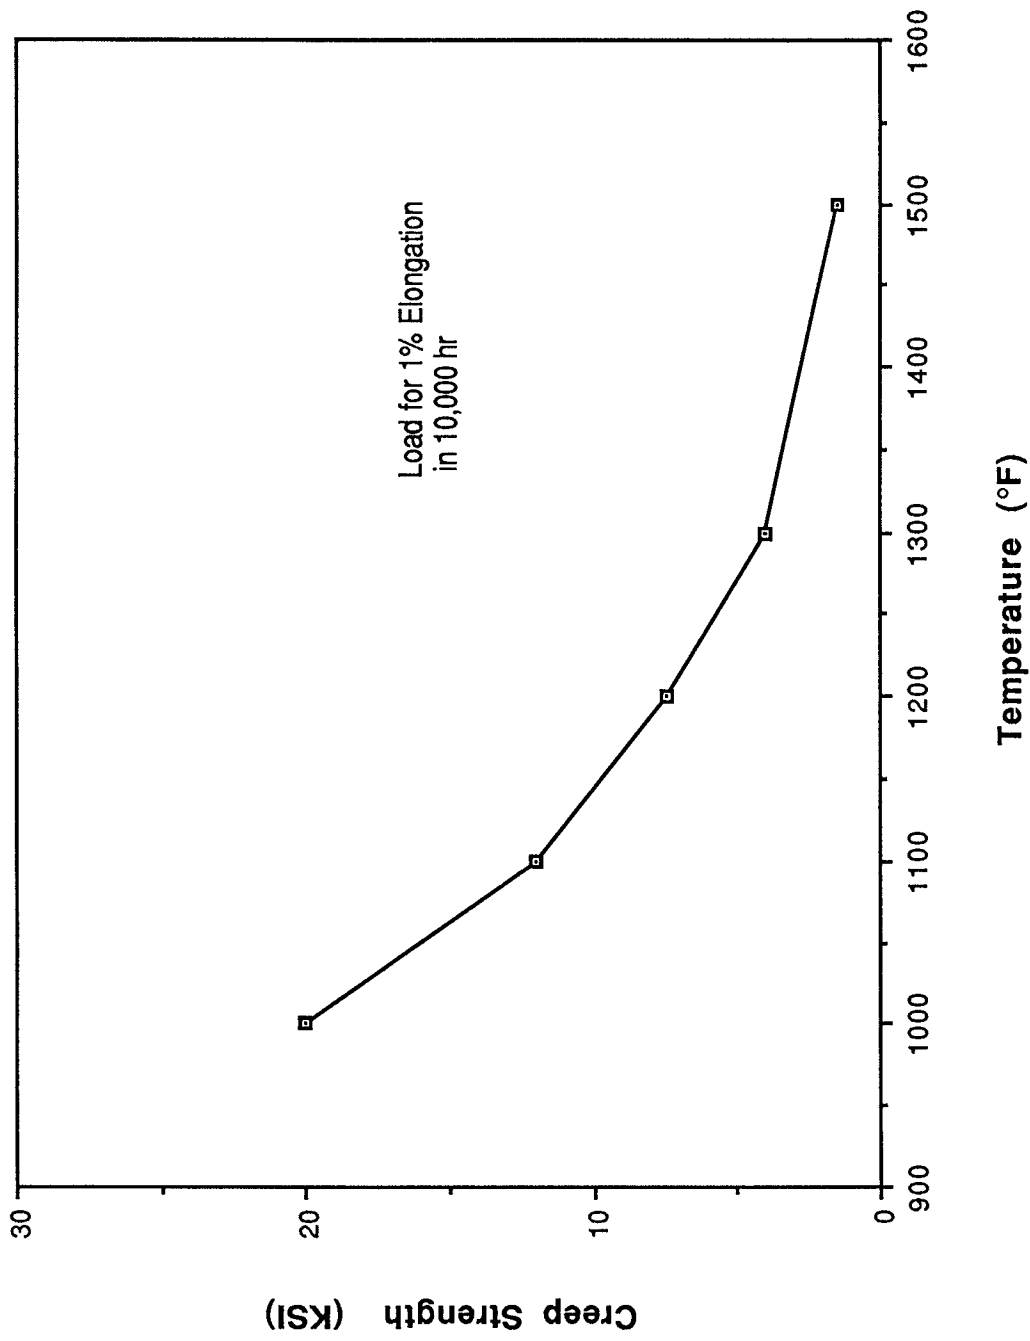
temperature under stress. Depending on the information source, the creep strength of AISI 304 stainless steel is reported as approximately 9.5 KSI at 1150°F and 3 KSI at 1350°F. Figure 3 illustrates the creep strength vs. temperature relationship for 304 stainless steel. For a long term installation such as this burner, the 304 stainless material should be limited to 1150°F.

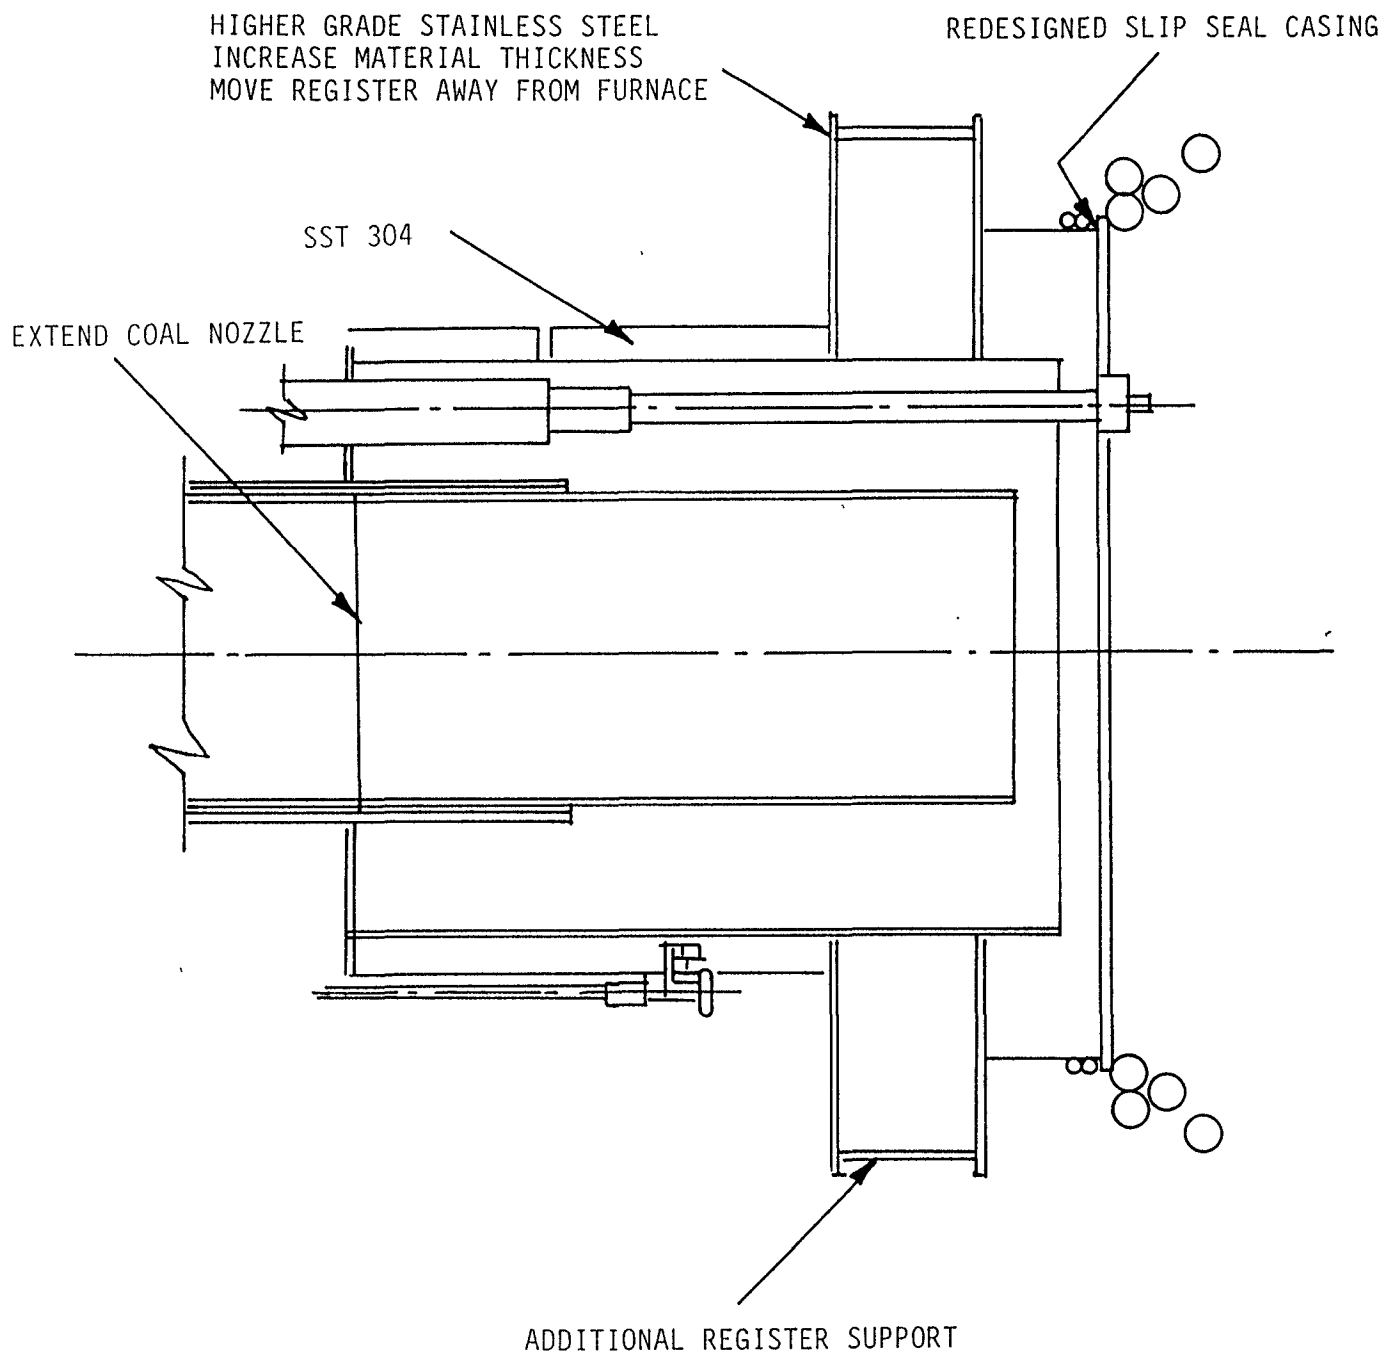
REDESIGNED BURNER
Figure 5

1. The stainless steel material and plate thickness should change on several of the burner components that have failed. This is evidenced by the current HD registers that have been installed in the upper row of burners and have already been permanently warped. A higher grade of stainless steel such as AISI 309 or 310 with a low carbon content would be better suited for high temperatures and welded constructions than a 304 material. This material would provide a higher creep strength and also alleviate long term effects of weld decay (Appendix C). Material thickness would probably also need to be increased on current 309 components to overcome the high stresses that are occurring.

Installing burners that have been redesigned to operate at 1350°F when they are out-of-service is the fourth alternative. The advantages of this alternative are that the boiler efficiency will not be affected and the estimated burner life would be 20-30 years. The burner would remain adjustable which would allow the cooling air flow to be balanced to each of the out-of-service burners. The new burner (see Figure 5) should incorporate the following design changes:

2. The outer register should use the HD register linkage design. This will increase the ability of the register to remain adjustable. Placing the outer register farther back from the furnace should also be considered. This would reduce the amount of heat transfer by radiation and assist in lowering the temperatures of the register back plate and doors. The disadvantage could be the reduction of swirl that is imparted to the secondary air. Considering that the existing burners have good stability while operating with low pressure drop across the burner and severely trimmed register doors, high swirl is evidently not required with the current fuel.
